13-TRO-276

# CORNER RECORD

City of BURBANK County of LOS ANGELES, California

Brief Legal Description SIXTH STREET & FAIRMOUNT ROAD

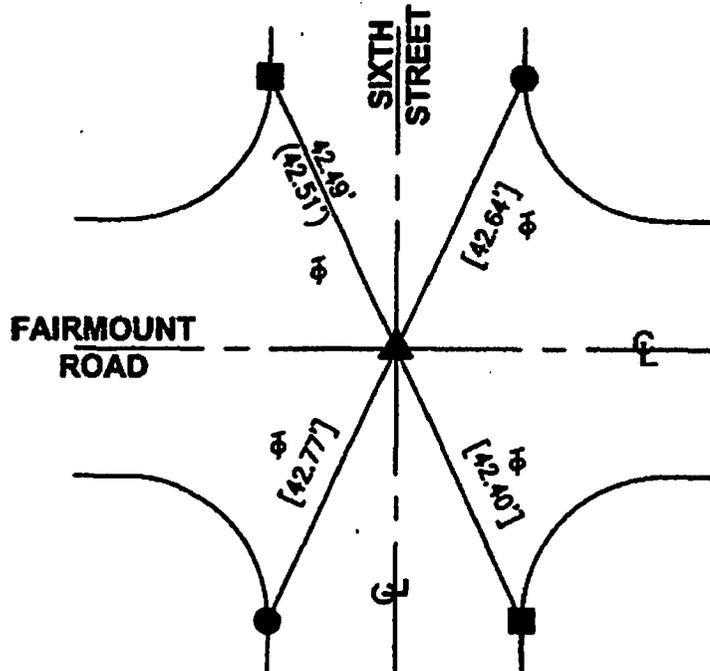
FB 338 P.335

R-1 = CITY OF BURBANK TIE SHEET BOOK 331, PAGE 130  
 ( ) = RECORD DISTANCE PER R-1  
 [ ] = RECORD & MEASURED DISTANCE PER R-1  
 ⌀ = TANGENT OVER

- ▲ FD. PUNCHED DOME SPK/W "C.E." FLUSH PER R-1 BEFORE CONSTRUCTION. SET MAG. N/W "LS 5411" FLUSH PER TIES HEREON AFTER CONSTRUCTION.
- FD. L/T "C.E." & CHISELED "T" IN T.C. PER R-1.
- FD L/R & CHISELED "T" IN T.C. PER R-1.
